# Leak detection with helium

### Finding leaks for United Utilities with iDroloc

Water for the North West

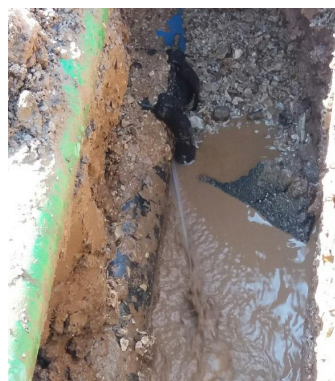
iDroloc is an effective leak detection system that uses helium as a tracer gas to prevent any interruptions to the water service, providing an innovative solution compared to more traditional techniques. The technology can be applied to large diameter mainlines, small distribution pipes, or connections within an urban area, providing a unique adaptable solution.

Throughout the network survey, iDroloc got a clear reading of an abnormal amount of helium which indicates the presence of water underground and the possibility of a leak. SUEZ technicians marked a one metre square area based on the helium readings. The repair was undertaken a few days later and the leak was located exactly in the demarked area which demonstrates the accuracy of iDroloc compared to acoustic and traditional methods.
